Inspection Report

ABC Corporation

Property Address:
100 Crossroads Blvd.
Goodtown NY 11666

Subject property is a two story wood frame structure estimated to be 40-45 years old. Building is a commercial property constructed to accommodate offices on first and second floors. Visible evidence indicates an acceptable level of construction. Subject property has been unoccupied/vacant for an unknown period of time.

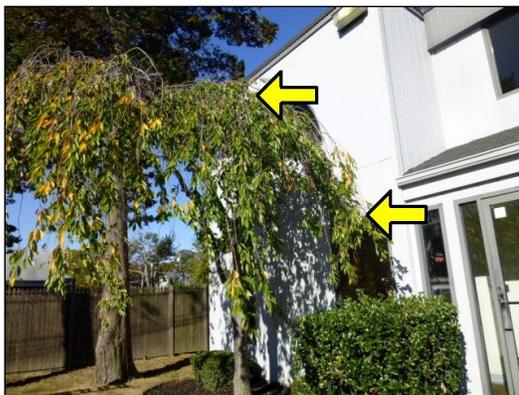
fig. 1

North yard exterior landscaping is unmaintained and in poor condition. Perimeter trees and shrubs contact building at various locations (fig. 1). Remaining tree stumps and surface roots were noted. Aged/potentially diseased trees exist resending potential risk of property damage (fig. 2). Further evaluation and maintenance by a licensed tree/landscape specialist is advised. West yard wood perimeter fence appears well installed and in good condition (fig. 3).

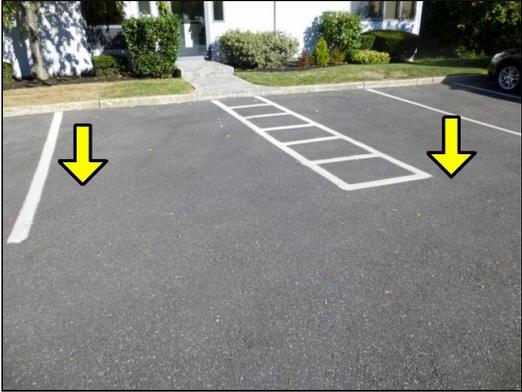
fig. 4

Asphalt parking field surface appears in good condition (fig. 4), typical settlement and cracking noted at various locations, recommend routine future seal-coat applications. Routine maintenance of parking lot storm drains is advised to ensure proper drainage (fig. 5). Expansion to north yard will augment existing parking.

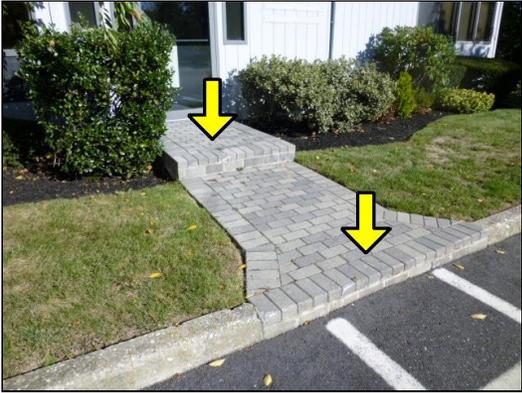
fig. 6

Loose/unsecured paving bricks were noted at south main entry porch (fig. 6). Further inspection and repair by a licensed masonry contractor is advised to reduce risk of trip hazard and accidental personal injury.

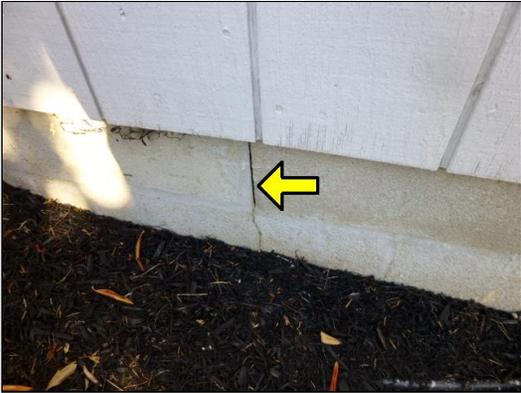
fig. 7

Visible exterior concrete block foundation walls appear in good condition. Minor settlement cracks were noted at various wall locations (fig. 7). This condition is considered common and typical.

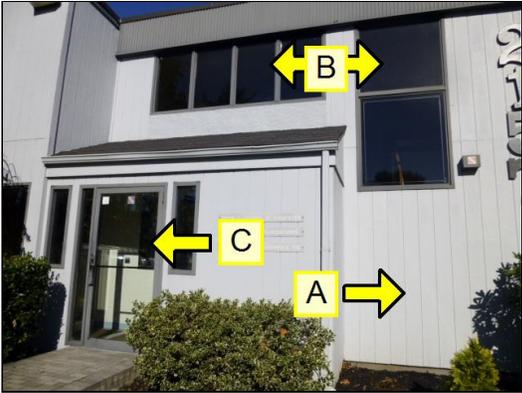
fig. 8

Exterior wood wall siding materials appear well installed and in satisfactory condition (fig. 8a, 9a). Recommend routine future power-washing and wood preservative applications.

Windows are estimated to be 20+ years old, are of builders grade quality, and typically develop failed thermal seals resulting in visible interior glass condensation stains (fig. 8b). Future replacement will be required. Failed thermal seals were noted at numerous windows repair or replacement is recommended. Remaining original wood/aluminum frame windows appear aged and in deteriorated condition (fig. 9b). Poor trim, wood rot, and deteriorated caulking joints are present. Advise scrape, sand, repair, re-caulking, and re-painting to reduce risk of moisture and cold air infiltration. Future installation of replacement windows is recommended.

South exterior entry doors are operational and in good condition (fig. 8c). North exterior entry door is aged and not operational. Required building egress is obstructed (fig. 9c). Repair or replacement by a licensed specialist is advised to reduce potential security and safety risk due to present condition.

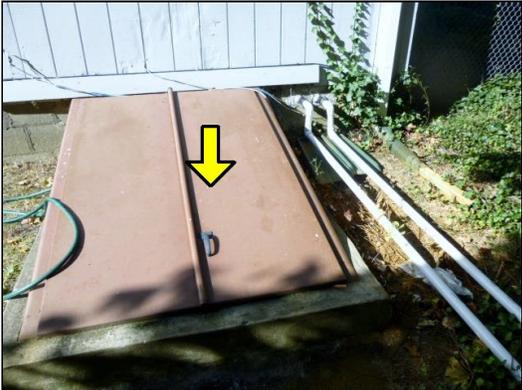
fig. 10

Basement walk-out area appears in good condition (fig. 10). Advise routine maintenance of floor drain to reduce risk of basement water penetration. Advise installation of stairway safety railing to reduce risk of trip hazard.

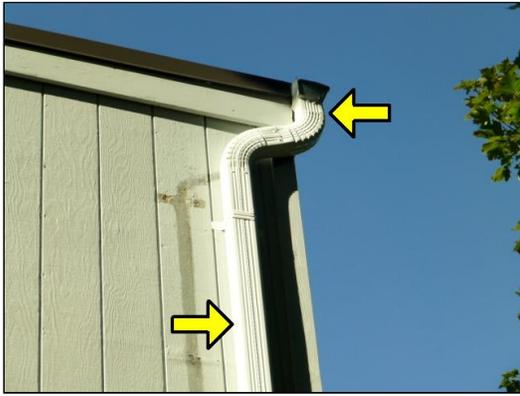
fig. 11

Aluminum gutter and downspout systems appear in good condition (fig. 11). Advise installation of downspout extensions and routine removal of debris from gutter systems to ensure proper roof drainage.

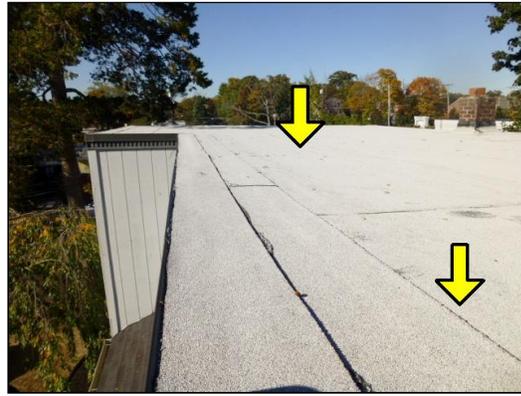
fig. 12

Asphalt roll roof surface appears professionally installed, in good condition, and is estimated to be 5 years old (fig. 12, 13a). Typical life cycle is 12-15 years. Roof surface is covered with multiple layers of asphalt roofing materials meeting code compliant limit and will require complete tear-off when re-roofing. Any deteriorated or rotted wood sheathing sections found when re-roofing will require replacement. Replacement with rubber membrane roofing materials is recommended when re-roofing.

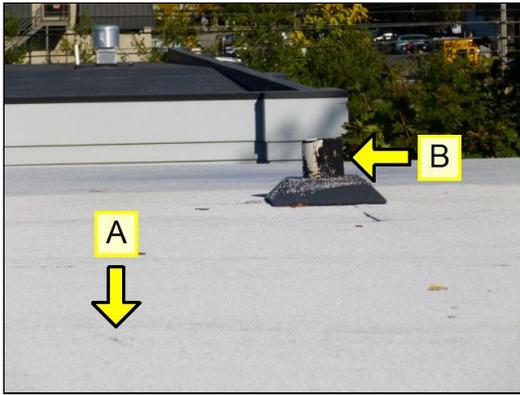
fig. 13

Roof accessories and visible flashing appear in satisfactory condition (fig. 13b).

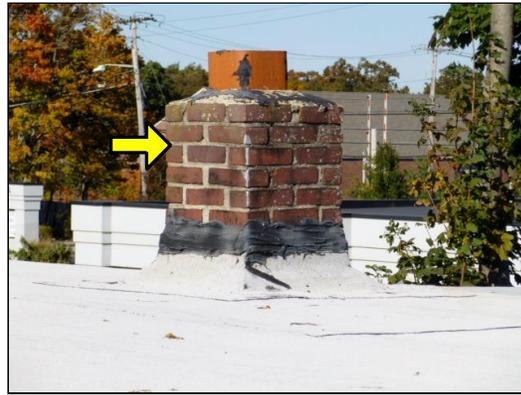
fig. 14

Brick chimney vent structure appears in satisfactory condition but is currently not in use (fig. 14). Installation of exterior flue liner rain cap is recommended.

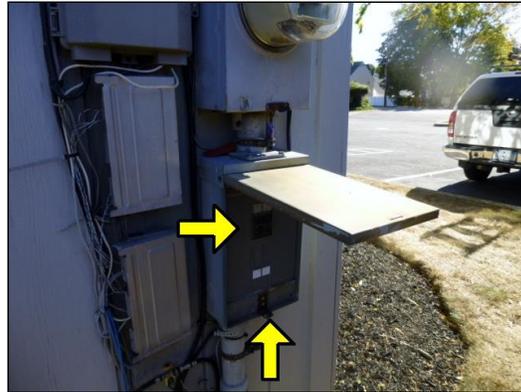
fig. 16

Electrical components have been updated, appear professionally installed, and are in functional condition. Electrical service consists of one (1) 225 amp copper service entrance cable servicing one (1) 225 amp main distribution panel located in basement (fig. 15). Electrical system 225 amp main disconnect breaker is located at west exterior wall meter pan (fig. 16). Installation of a pad-lock is advised to reduce risk of tampering.

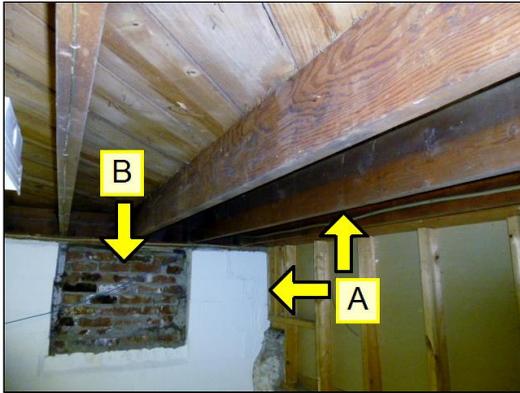
fig. 17

Basement is constructed with concrete block foundation walls and standard wood framing components (fig. 17a). High moisture readings of up to 39.5% were present at perimeter wall locations tested. Visible evidence of regular moisture/ water penetration was observed. Absence of adequate water proofing on exterior foundation walls, local ground soil conditions, and a high water table are considered a contributing factors. Perimeter drainage system is serviced by northeast basement sump-pumps (2) (fig. 18). Future installation of battery back-up systems for sump-pumps is recommended. Routine maintenance of exterior roof gutter drainage systems and installation of a dehumidifier/air exchanger will reduce basement moisture levels. Visible construction and wood framing components appear in good condition. Perimeter crib walls have been constructed to reinforce original foundation walls, concrete floor was raised to accommodate drainage system. Absence of cross bridging between floor joist was observed, future blocking by a licensed specialist is recommended for improved structural support. No visible evidence of active wood destroying insect infestation is present, however, continued preventive maintenance coverage by a licensed pest control specialist is advised.

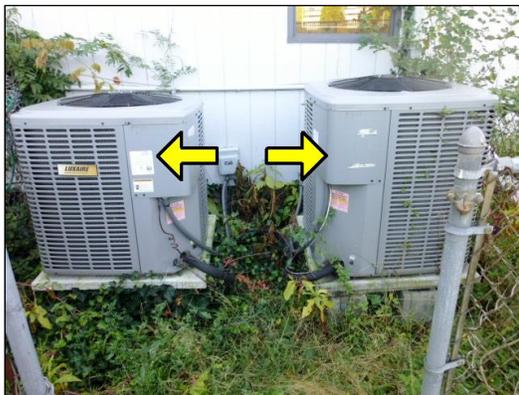
fig. 19

Heating components consist of two electric fired forced hot air A/C-Heat-Pump systems estimated to be 5 years old (fig. 19). Systems are operational and appear in good condition. Advise continued maintenance coverage by a licensed HVAC contractor and installation of functional smoke and C/O detectors on all floors. Clear and maintain vegetation from exterior units to reduce interference with proper function.

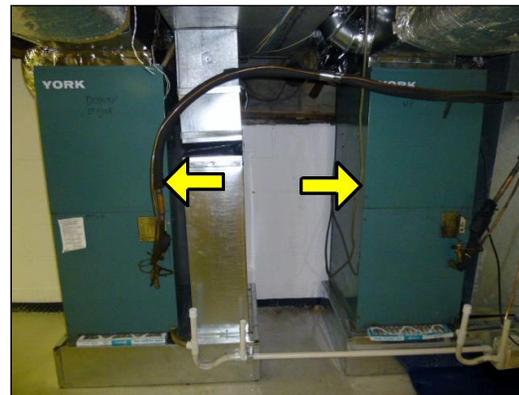
fig. 20

Forced air components (2 air handlers) are operational. Check filters monthly - service when dirty. **Basement area HVAC air handlers (2 units) pre-date exterior compressors and are estimated to be 20+ years old (fig. 20). Advise continued maintenance coverage by a licensed A/C contractor, anticipate future repairs and or replacement.** An ambient air test was performed by using thermometers on the air handler of central A/C system to determine if the difference in temperatures of the supply and return air are between 14 degrees and 22 degrees which indicates that the unit is cooling as intended. The supply and return air temperature on system conformed to these specifications. This indicates proper operation.

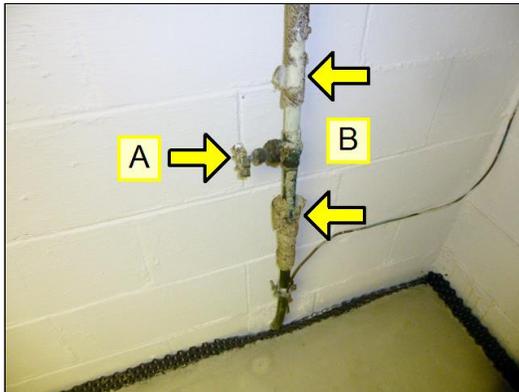
fig. 21

Water main shut off valve is located at southwest basement corner (fig. 21a). **Water main supply piping is insulated with asbestos like material. Insulation is deteriorated and friable (fig. 21b). Further evaluation and abatement or encapsulation by a licensed environmental specialist is advised.**

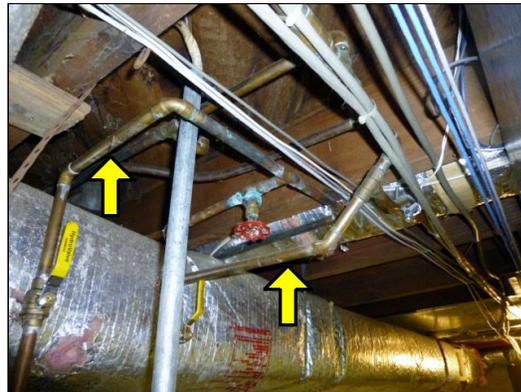
fig. 22

Visible copper plumbing hot and cold water supply components appear professionally installed and in satisfactory condition (fig. 22).

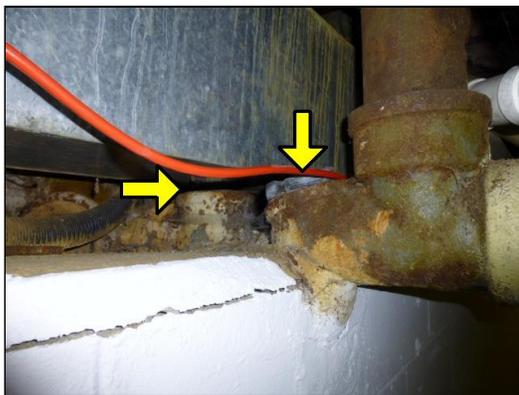
fig. 23

Waste drainage performance was normal at time of inspection. Visible evidence of past treatment/service was noted at main waste drainage line access trap (fig. 23). Periodic blockage from exterior yard tree root systems is suspected. Future treatment/service by a licensed cesspool and drain contractor will be required. Main waste trap in obstructed by HVAC ductwork, installation of improved access is advised to ensure sufficient service access. **Verifying that a waste line connection to municipal sewer system exists (if available) through municipal records or by a licensed sewer and drain contractor is advised.**

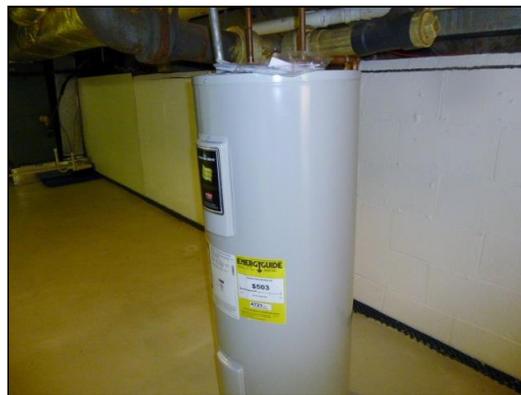
fig. 24

Electric fired hot water heater is operational and appears in good condition (fig. 24). Water heater is estimated to be 1 year old, typical life cycle is 12-15 years.
