# Inspection Report

**Property Address:**  
72 Pine Street  
Springfield NY 11888

**Inspection Date: 11/21/2013**  
**Report ID: 112113B2**

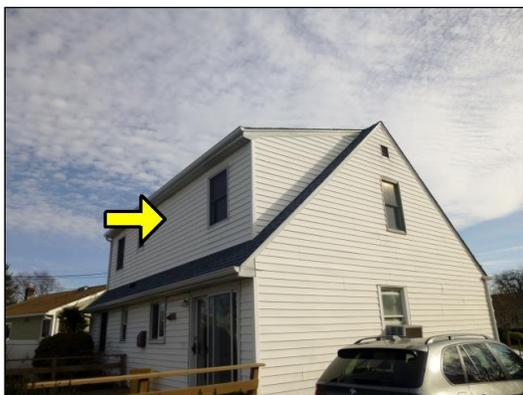
fig. 1

**North second story roof dormer building extension appears professionally constructed and in good condition (fig. 1). Such improvements typically require municipal building permits and occupancy certificates to ensure building and safety code compliance.**

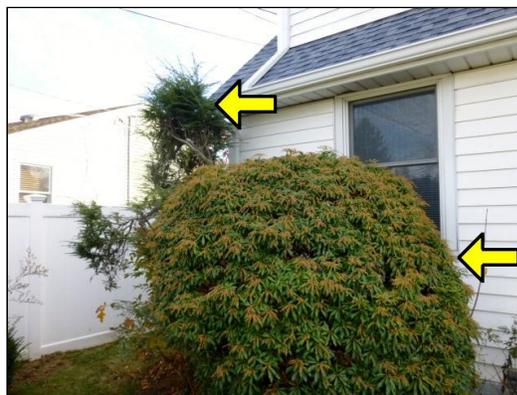
fig. 2

Exterior landscaping appears well maintained and in good condition. Perimeter trees and shrubs contact building at various locations (fig. 2), advise routine future maintenance by a licensed tree/landscape specialist. North yard pvc perimeter fencing appears well installed and in good condition.

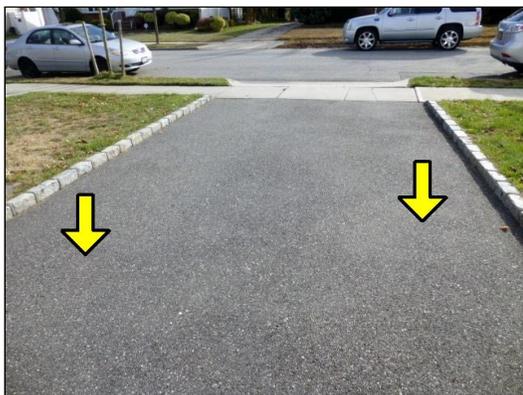
fig. 3

Asphalt driveway surface appears in good condition (fig. 3), typical settlement and cracking noted at various locations, recommend routine future seal-coat applications.

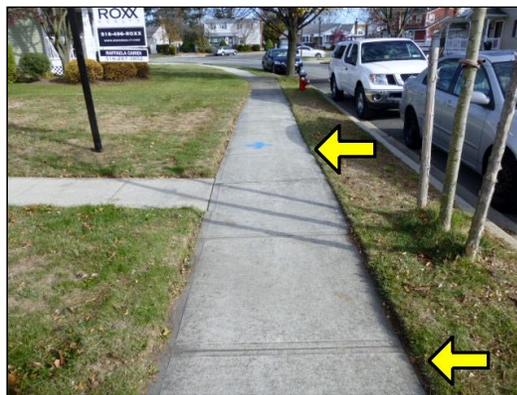
fig. 4

Concrete perimeter walkways appear professionally installed and in good condition (fig. 4). Typical surface settlement and cracking is present.

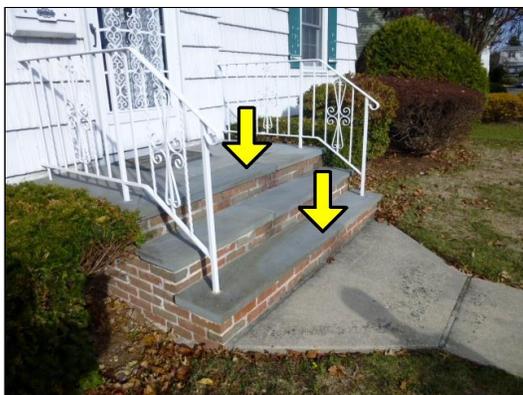
fig. 5

South paving stone and brick main entry porch appears well installed and in good condition (fig. 5). Typical settlement and surface cracking was noted. Advise routine future power washing to remove moss growth and reduce risk of trip hazard.

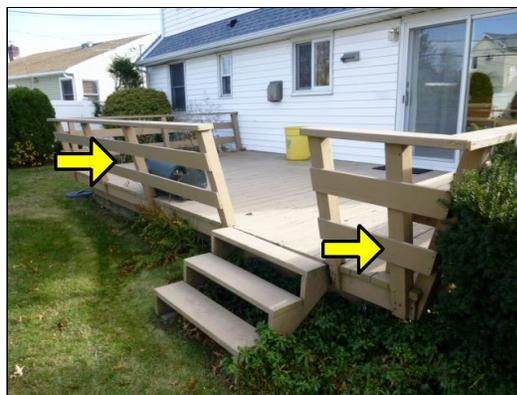
fig. 6

Visible evidence indicates that north yard wood deck pre-dates current local building code standards but typical of similarly aged decks (fig. 6). Such structures typically require municipal building permits and occupancy certificates to ensure an acceptable level of construction. Ledger board is not lag bolted to building, absence of steel joist hangers, excessive span between floor joists, absence of concrete footings for wood support posts, and advanced wood rot was noted (fig. 7). Further inspection, reinforcement, repair, power wash, and wood preservative application by a licensed deck specialist is advised. Future demolition and replacement is recommended.

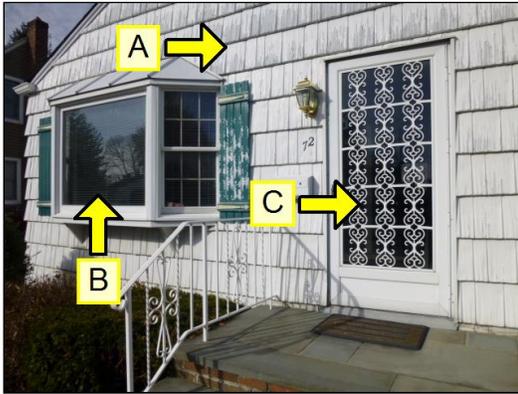
fig. 9

Exterior vinyl wall siding materials appear well installed and in good condition (fig. 9a). Recommend future power-washing to remove moss/mold growth. **South exterior wall aluminum wall siding materials appear well installed but aged, worn, and in deteriorated condition (fig. 9a, 10a). Priming and repainting is advised to reduce risk of further deterioration. Future installation of replacement siding is recommended.**

Exterior windows have been updated with thermal insulated replacements and appear well trimmed and sealed (fig. 8b, 9b, 10b). Advise routine re-caulking of exterior window frames as needed to reduce risk of moisture and cold air infiltration.

Exterior entry doors are operational and in good condition (fig. 8c, 9c).

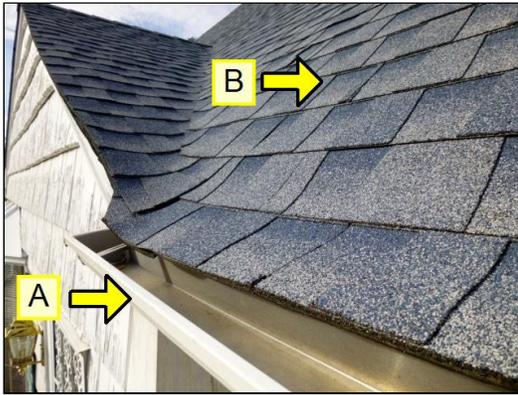
fig. 11

Aluminum gutter and downspout systems appear in good condition (fig. 11a). Advise installation of downspout extensions and routine removal of debris from gutter systems to ensure proper roof drainage.

Asphalt shingle roof surface appears professionally installed, in good condition, and is estimated to be 3 years old (fig. 11b, 12). Typical life cycle is 25-30 years.

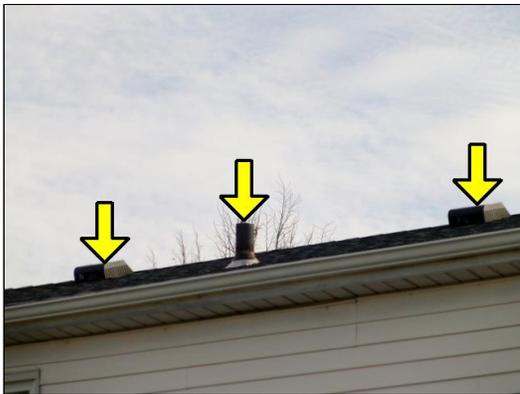
fig. 13

Roof accessories and visible flashing appear in good condition (fig. 13).

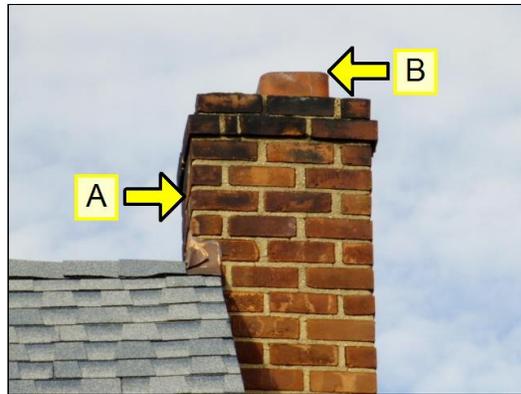
fig. 14

Brick chimney vent structure appears in satisfactory condition (fig. 14a). **Installation of an exterior flue liner rain cap by a licensed chimney specialist is advised (fig. 14b).**

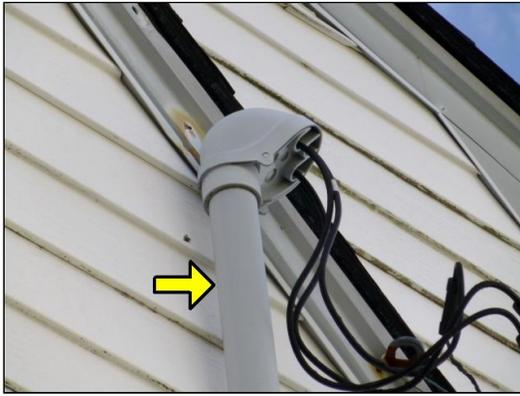
fig. 15

Exterior electrical service entrance cable conduit is poorly secured to building wall presenting a potential electrical hazard (fig. 15). Further inspection and repair by a licensed electrical contractor is advised.

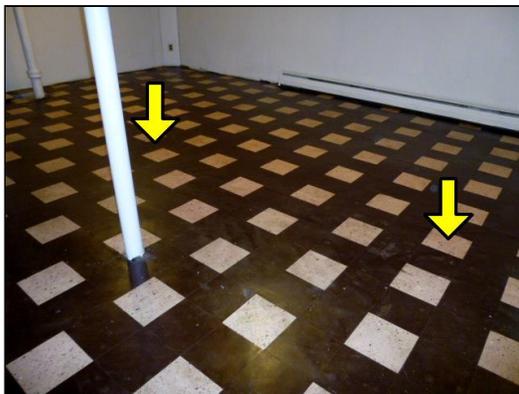
fig. 17

Various cracks in concrete floor and wall surfaces are considered typical and common. Vinyl flooring tiles are aged and may contain asbestos (fig. 17). Installation of updated flooring materials are commonly installed directly over these flooring materials. Removal by a licensed specialist is advised if replacing.

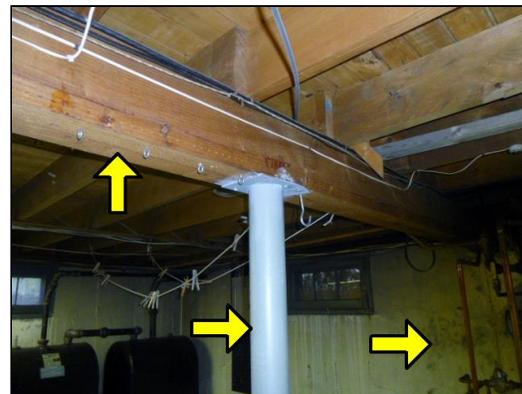
fig. 18

Basement is constructed with poured concrete foundation walls and standard wood framing components (fig. 18, 19). Basement area is partially finished with fixed floor, wall, and ceiling covers preventing complete inspection of construction components. Low moisture readings of up to 15.4% were present at perimeter wall locations tested. However, visible evidence of past moisture/water penetration and minor resulting mold/mildew condition was observed (fig. 20). Routine use of basement windows for improved ventilation, maintenance of exterior roof gutter drainage systems, and installation of a dehumidifier will reduce basement moisture levels. Visible construction and wood framing components appear in good condition. No visible evidence of active wood destroying insect infestation is present, however, continued preventive maintenance coverage by a licensed pest control specialist is advised.

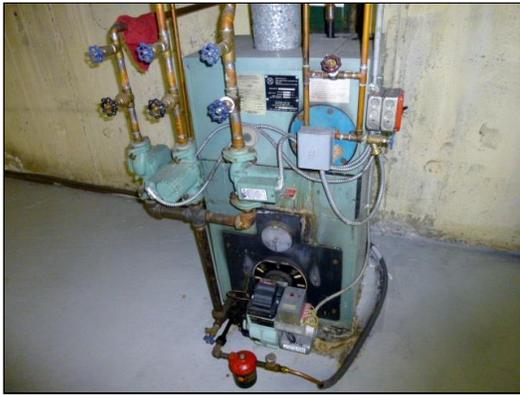
fig. 21

Heating system is an oil fired circulating hot water system estimated to be 20-25 years old (fig. 21). System is supplied by two 120 gallon oil tanks (240 USG total) located in basement (fig. 22). System is operational, no C/O emission was detected. Advise continued maintenance coverage by a licensed heating contractor and installation of functional smoke and C/O detectors on all floors. Installation of fire proofing material above boiler unit is recommended.

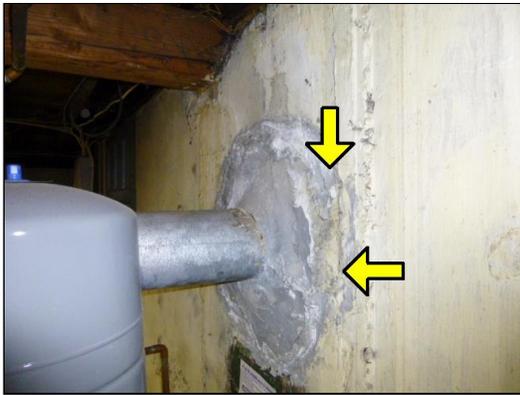
fig. 23

Advanced deterioration/corrosion of boiler emission vent stack connection to chimney was observed (fig. 23). This condition could deteriorate and result in CO leakage to building interior presenting a serious health and safety hazard. Further inspection and repair by a licensed heating specialist is advised.

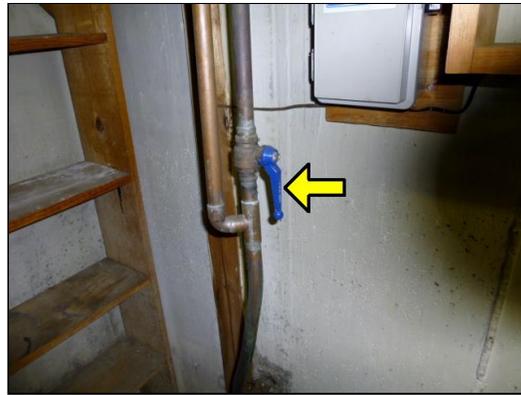
fig. 24

Water main shut off valve is located at southeast basement corner (fig. 24). Absence of an approved back-flow preventer valve for in-ground irrigation system was noted. Installation by a licensed plumbing contractor is advised.

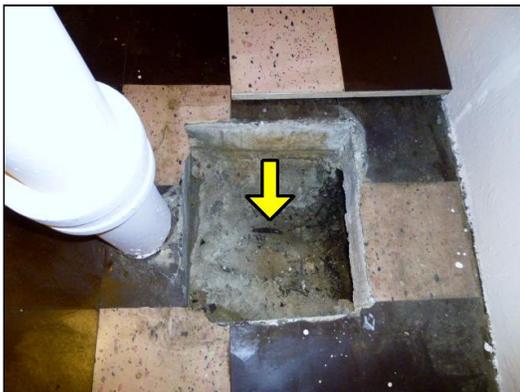
fig. 25

Waste drainage performance was normal at time of inspection. Visible evidence of past treatment/service was noted at main waste drainage line access trap (fig. 25). Periodic blockage from exterior yard tree root systems is suspected. Future treatment/service by a licensed sewer and drain contractor will be required. Remaining galvanized steel waste drainage components are subject to higher failure rate and may require future service/replacement (fig. 26).

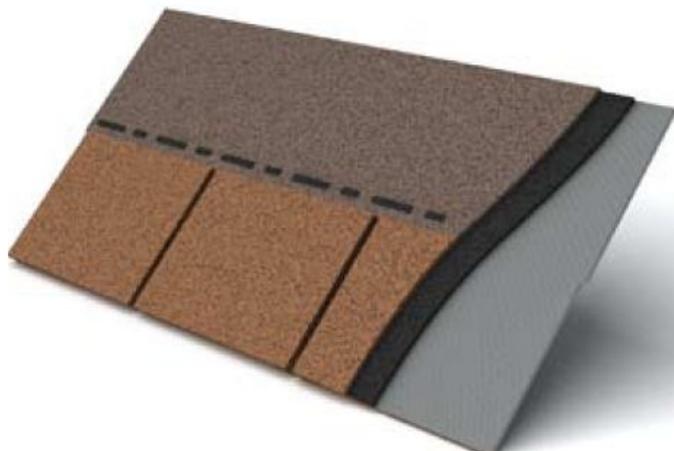
The two common base layer materials are paper saturated in asphalt and fiberglass. While they are both asphalt shingles, they are often referred to as organic and fiberglass respectively. Fiberglass base shingles were developed to use less of the expensive asphalt but still maintain the same shingle life. The main difference is that the fiberglass based shingle is thinner and lighter than the equivalent organic shingle, making it more desirable for installers. Organic shingles are thicker and heavier and are considered to have better durability and tear resistance. Fiberglass based shingles are more flexible in hot weather and may perform better in wind storms. Both types are used successfully in most climates. There have been problems reported with fiberglass based shingles involving cracking of the shingles due to thermal stress (large temperature fluctuations). These problems are less prevalent now as new standards for manufacturing these shingles have been adopted by most manufacturers.

*Three layers of an asphalt shingle*
